ABSTRACT

This document describes the known exceptions to the functional specifications (advisories).

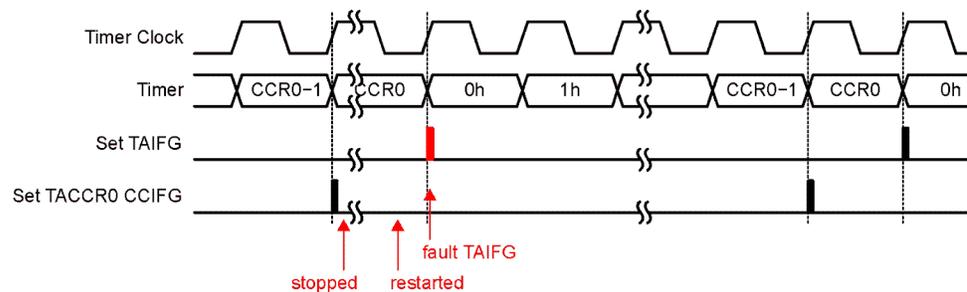
TA21 *TA Module*

Function TAIFG Flag is erroneously set after Timer A restarts in Up Mode

Description In Up Mode, the TAIFG flag should only be set when the timer counts from TACCR0 to zero. However, if the Timer A is stopped at $TAR = TACCR0$, then cleared ($TAR=0$) by setting the TACLR bit, and finally restarted in Up Mode, the next rising edge of the TACLK will erroneously set the TAIFG flag.

Workaround None.
