## dsPIC33CH512MP508 Family Silicon Errata and Data Sheet Clarification

The dsPIC33CH512MP508 family devices that you have received conform functionally to the current Device Data Sheet (DS70005371D), except for the anomalies described in this document.

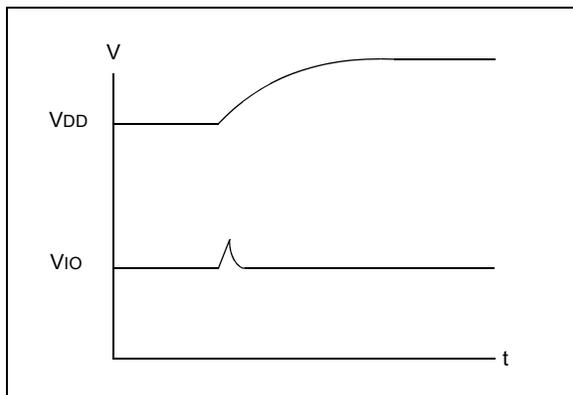
**FIGURE 1-1: I/O RAMP**

During a fast device power-up, when the VDD ramp is less than 4 mS, the I/O pins may drive up to 100  $\mu$ A current for a duration of up to 10  $\mu$ S (Figure 1-1).

Example applications affected may include complementary power switches, where a transient current shoot-through might occur. High-voltage applications with complementary switches should power the high-voltage 200  $\mu$ Sec later than powering the dsPIC<sup>®</sup> device to avoid the current shoot-through. This behavior is specific to each device and not affected by aging.

1. Slow down the VDD ramp time (greater than 4 mS for VDD to ramp 0V to 3.3V).
2. Ensure the circuitry that is connected to the pins can endure this pulse.
