PIC18C658/858

PIC18C658/858 Rev. B1 Silicon/Data Sheet Errata

The PIC18C658/858 parts you have received conform functionally to the Device Data Sheet (DS30475**A**), except for the anomalies described below.

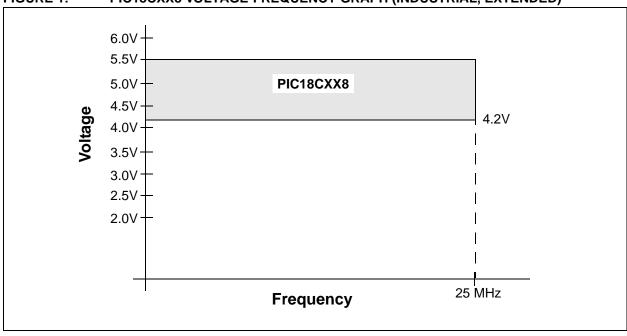
FIGURE 1: PIC18CXX8 VOLTAGE-FREQUENCY GRAPH (INDUSTRIAL, EXTENDED)

The device may not operate properly at frequencies exceeding 25 MHz. The graphs in Figures 1 and 2 show the expected voltage vs. frequency operating range for standard voltage range and extended voltage range devices, respectively.

None. This issue is expected to be resolved in a future silicon revision. Please contact a Microchip sales office for additional information on availability.

The operating frequency range for extended temperature devices has been changed.

The maximum external clock frequency (EC and ECIO modes) and oscillator frequency (HS mode) for extended temperature devices has been changed to 25 MHz. When the PLL is used (HS+PLL mode), the maximum clock and oscillator frequency has been changed to 6.25 MHz. Other values of related parameters have changed accordingly.

The title of Figure 25-1 is amended to read:

"PIC18CXX8 Voltage-Frequency Graph (Industrial, Extended)"

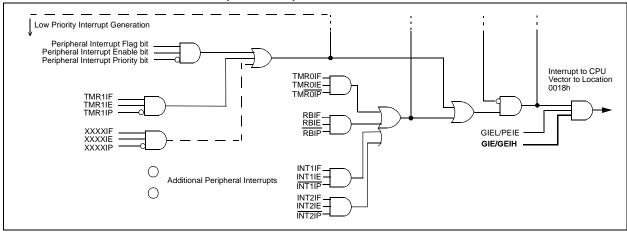
FIGURE 1: INTERRUPT LOGIC (EXCERPT)

The operation of the GIE/GIEH bit (INTCON<7>) is clarified as follows: when the bit is cleared, all interrupts are disabled. This is regardless of the state of the IPEN bit (RCON<7>), the priority of the interrupt, or whether or not the interrupt is unmasked. This varies from the original description, in which clearing the bit when IPEN = 1 would only disable high priority interrupts.

Also, the interrupt logic funnel shown in Figure 7-1 of the Device Data Sheet is amended with the addition of a GIE/GIEH control line, as shown in Figure 1 (new material in **bold line**).
